# General Condition and Valuation Survey

**“Swell Bound”**  
**1996 Hunter 42 Passage CC**  
**06-06-2023 & 06-13-2023**

***Arran Flanagan***  
***Marine Surveyor***

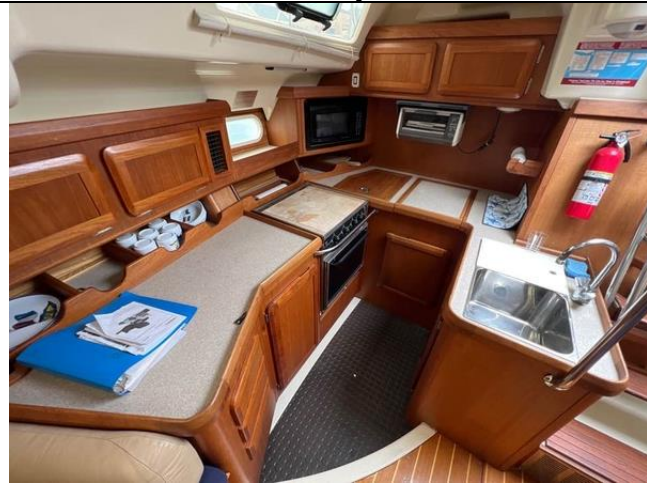
Galley

Notes: The oven knob is inoperative. Diagnose and repair as appropriate.

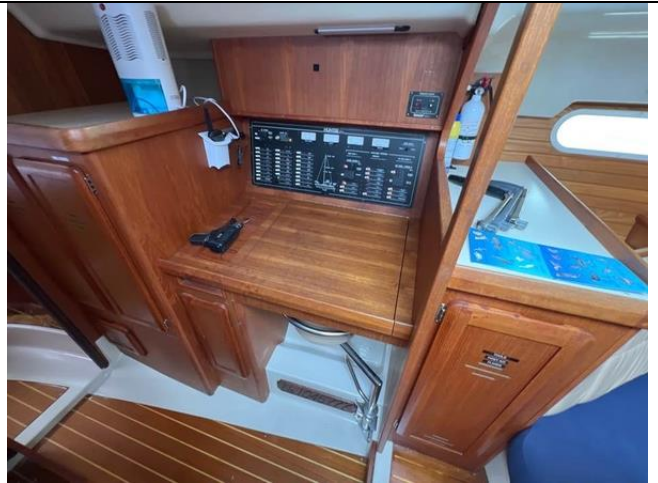
Nav station

1. 110-volt GFCI receptacle in the nav station is not operating properly and must be repaired or replaced per NFPA 302 section 8-11.1 recommendations.
2. The A type fuel hoses are older than 10 years. Type A fuel hoses according to manufactures standards must be replaced every 10 years. replace accordingly.
3. The anchor shackle should be moused.
4. Bonding wires and connections were found to be corroded. Service as appropriate.
5. The generator battery bank Per ABYC E 10.8.3 Battery cables shall not be connected to the battery with wing nuts.

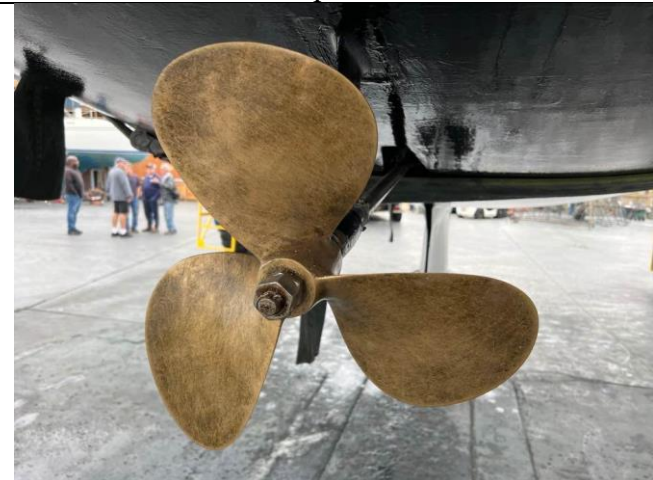
Propellers

**Last haulout date:** 2023 (rptd. by owner)  
**Hauled:** At Safe Harbor boatyard, San Diego, CA 06-13-2023  
**Keel:** winged, fin  
**Propeller:** One (1)  
Size: 18 x 14  
Number of blades: Three (3)-fixed blade prop  
Material: Nibral  
**Propeller Shaft:** 1¼" Diameter  
Material: Stainless steel  
**Shaft Bearing:** In serviceable condition.  
**Strut:** Cast bronze, I-beam  
**Rudder Material:** Fiberglass reinforced plastic  
**Rudder Mounting:** Spade  
**Strainers/Scoops/Screens:** Exterior clam shells were observed on some of the through hull fittings.  
Condition: Found to be clear of debris. Serviceable.  
**Transducers:** Depth and speed  
**Zincs:** Shaft zincs, Strut zincs  
Condition: None sighted

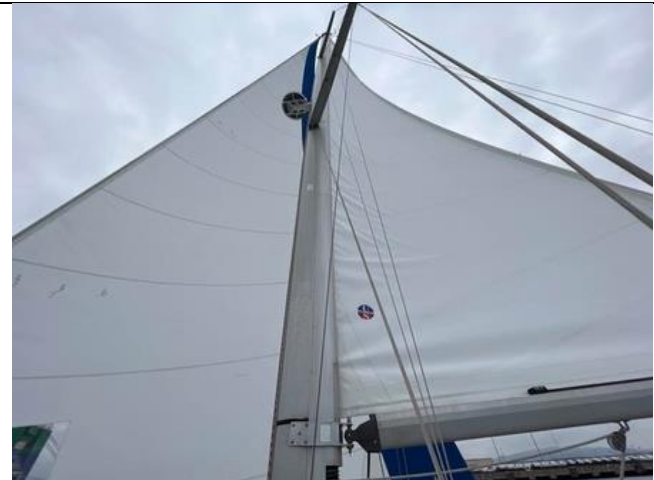
Sails

**Sails:** Dacron sails include genoa, main  
**Condition:** In overall good condition.

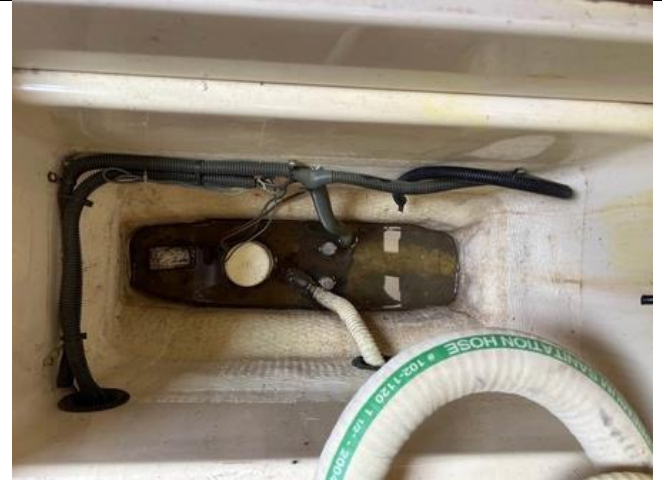
Mid bilge

1. Empty the standing water from the midship bilges. The source of any leakage should be determined and repaired as necessary.
2. The foredeck flood light is inoperative. Diagnose and repair as appropriate.
3. Signs of water damage was observed on the aft cabin floor.
4. The galley refrigerator does not cool. Diagnose and repair as appropriate.
5. One of the oven knobs is inoperative. Diagnose and repair as appropriate.
6. The forward air conditioning does not produce a cool temperature. Diagnose and repair as appropriate.
