# General Condition and Valuation Survey

**“No Name”**  
**2012 Regal 38 Express**  
**06-05-2023**

***Arran Flanagan***  
***Marine Surveyor***

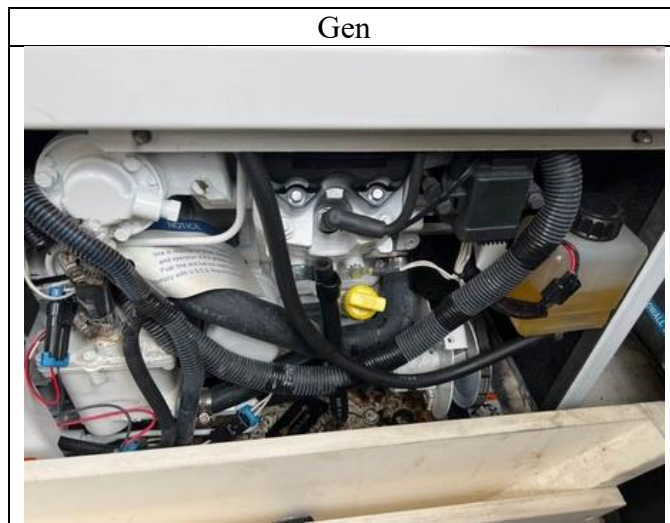
Location: Engine room

Notes: Generator shut down due to coolant loss alarm displayed on panel. Diagnose and repair as appropriate.

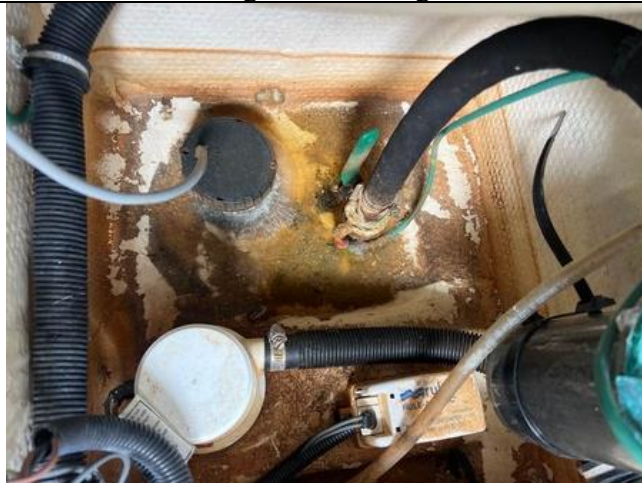
Engine room bilge

Note: Empty the standing water from the engine room bilges. The source of any leakage should be determined and repaired as necessary.
