# General Condition and Valuation Survey

**“Swell Bound”**  
**1996 Hunter 42 Passage CC**  
**06-06-2023 & 06-13-2023**

***Arran Flanagan***  
***Marine Surveyor***

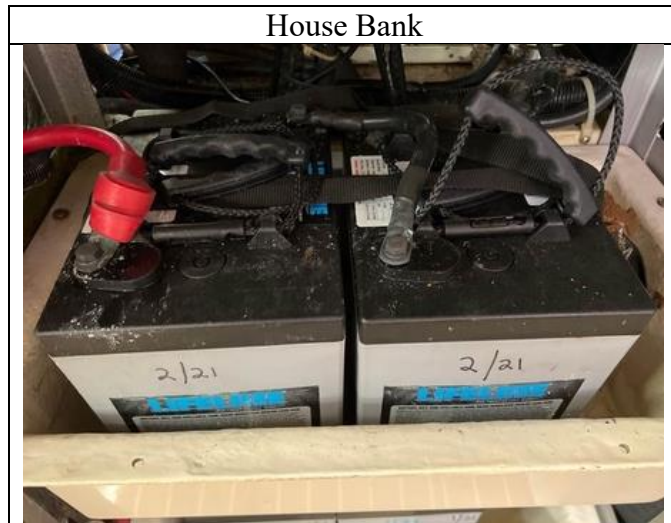
**House bank:** 12V wired in series (2) 6 V Lifeline, 4CT,  
**Dates:** 2-2021 (rptd. by owner)  
**Type:** AGM  
**Location:** Engine room  
**Condition:** In serviceable condition. **(internal condition unknown)**  
Secured, ventilated, contained, and terminals are covered.

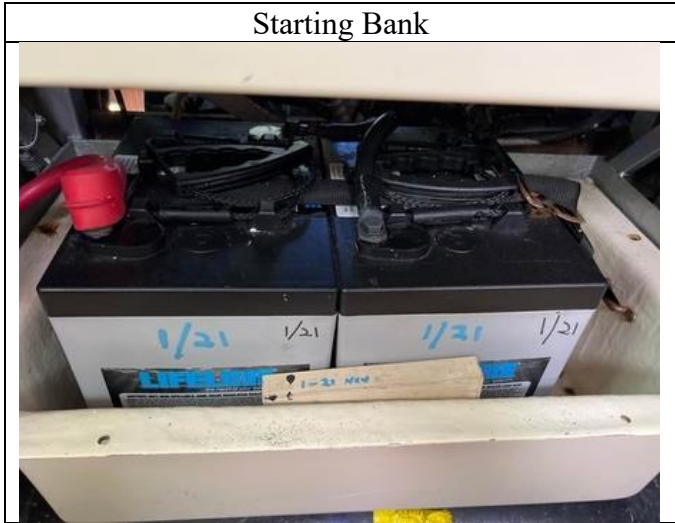
**Starting bank:** 12V wired in series (2) 6V Lifeline, 4CT,  
 Dates: 1-2021 (rptd. by owner)  
 Type: AGM  
 Location: Engine room  
 Condition: In serviceable condition. **(internal condition unknown)**  
 Secured, ventilated, contained, and terminals are covered.

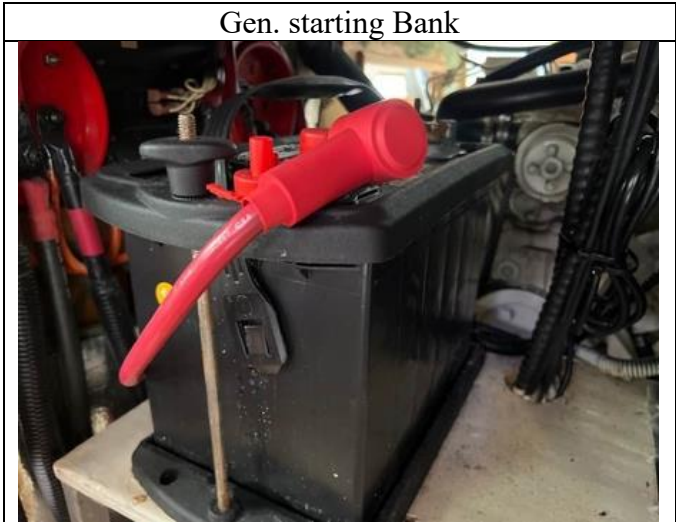
**Gen. starting bank:** 12V individual (1) Duralast, Group 24  
 Dates: 8-2020 (sighted)  
 Type: Lead acid  
 Location: Engine room  
 Condition: In serviceable condition. **(internal condition unknown)**  
 Secured, ventilated, contained, and terminals are covered.
