# General Condition and Valuation Survey

**“No Name”**  
**2012 Regal 38 Express**  
**06-05-2023**

***Arran Flanagan***  
***Marine Surveyor***

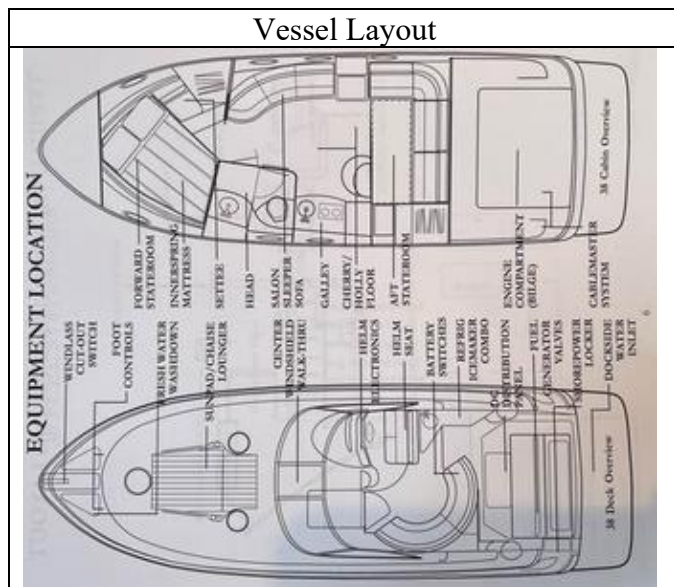
The vessel "No Name" was a 2012 Regal 38 Express, express cruiser with 430 HP Gasoline inboard engines, Modified-V, planing type, vee bottom, full keel, transom-ended design, and fiberglass reinforced plastic construction, with Cockpit helm.

Housekeeping and general appearance are **Average**. The vessel is normally equipped for her size and type. The hull has a shine and is in overall satisfactory condition. From examination afloat and hauled of accessible areas, the vessel appears to be sound, with no evidence of structural damage.

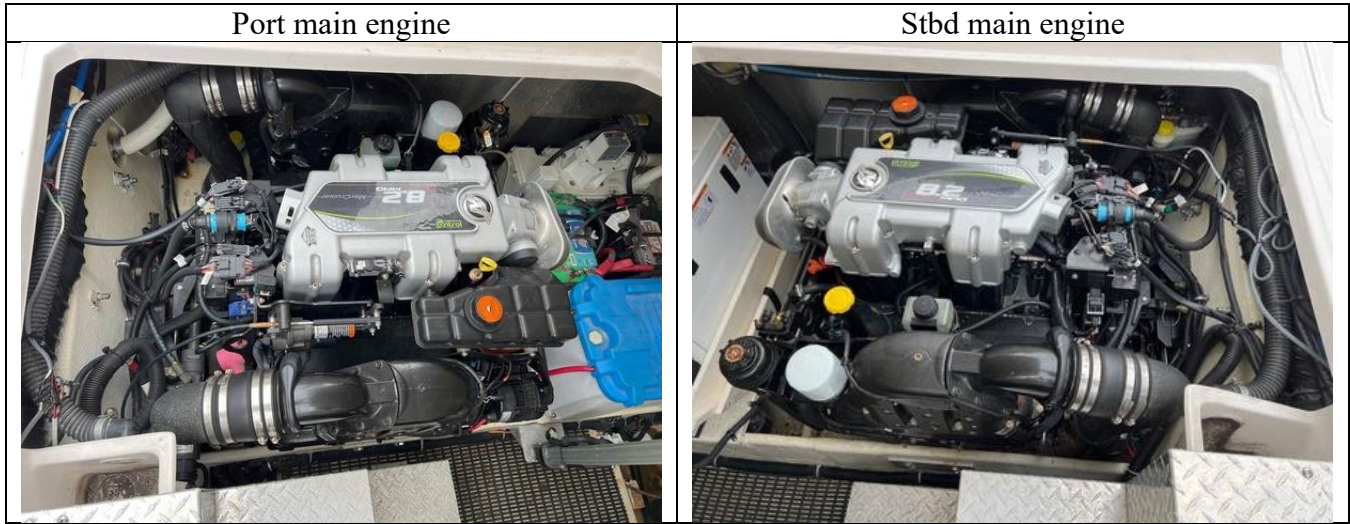
**Manufacturer:** Twin MerCruiser  
**Model:** 8.2 MAG  
**Type:** Gasoline, V8-cylinder  
**Rated HP:** 430 @ 4400 RPM  
**Serial numbers:** Port: 2A015031                      Stbd: 2A030516  
**Engine hours:** Port: 502                      Stbd: 510  
**Engine controls:** Single-lever, electronic, with Glendenning engine synchronizer, with joystick  
**Engine Shut Down:** Key for the engine on the helm console.

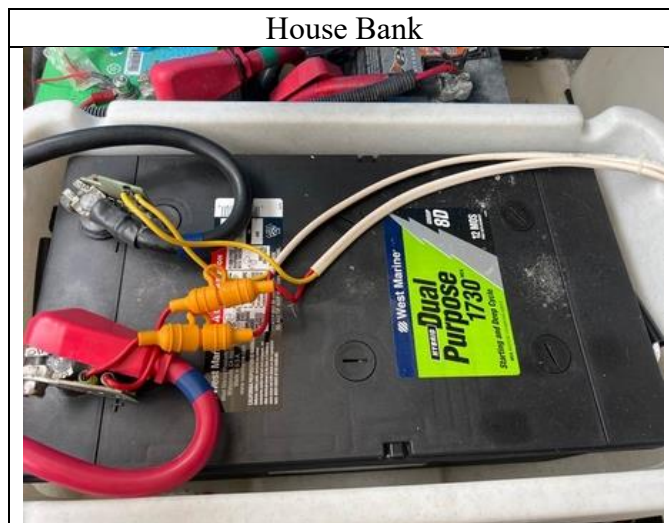
**House bank:** 12V individual (1) 12 V West Marine, 8D  
Dates: Not sighted  
Type: Lead acid  
Location: Engine room  
Condition: In serviceable condition. **(internal condition unknown)**  
Secured, ventilated, contained, and terminals are covered.  
**Battery charger:** Master VoltPower charger 12/40-3

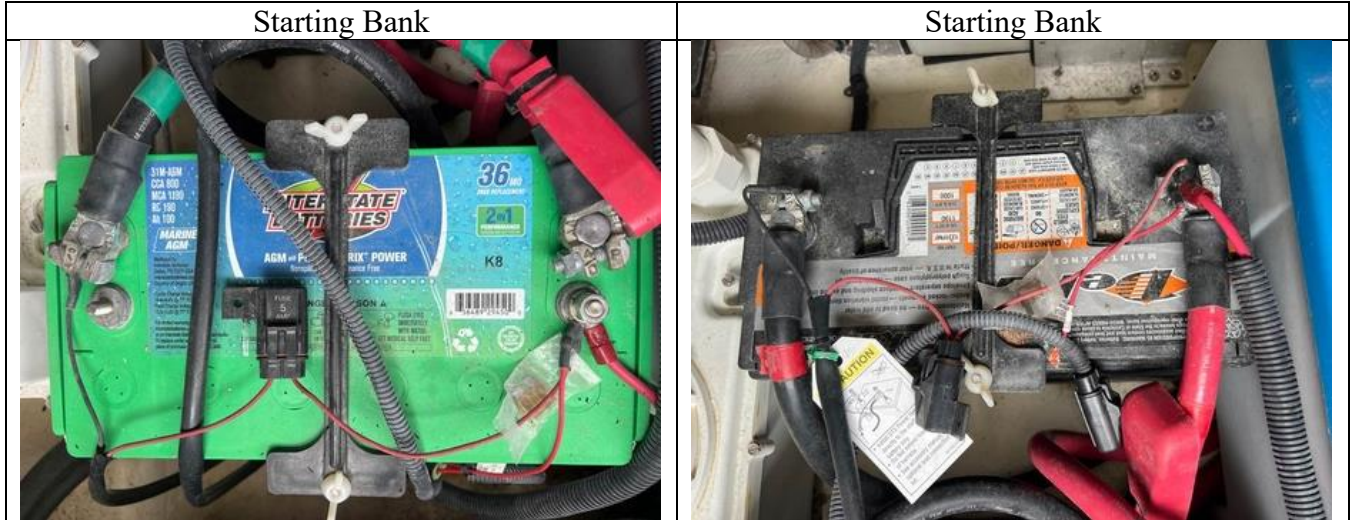
**Starting bank:** 12V individual (2) 12V Interstate batteries & Deka, Group 31  
**Dates:** Not sighted  
**Type:** AGM and Lead Acid  
**Location:** Engine room  
**Condition:** In serviceable condition. **(internal condition unknown)**  
 Secured, ventilated, not contained, and terminals are covered.  
**Battery charger:** Same as house
